**Chardon (OH) Building** - Learn how spray foam was installed over this unique and complex roof.

**Project Overview:** Spray Foam Roofing over Low-Slope Metal and Gravel BUR.

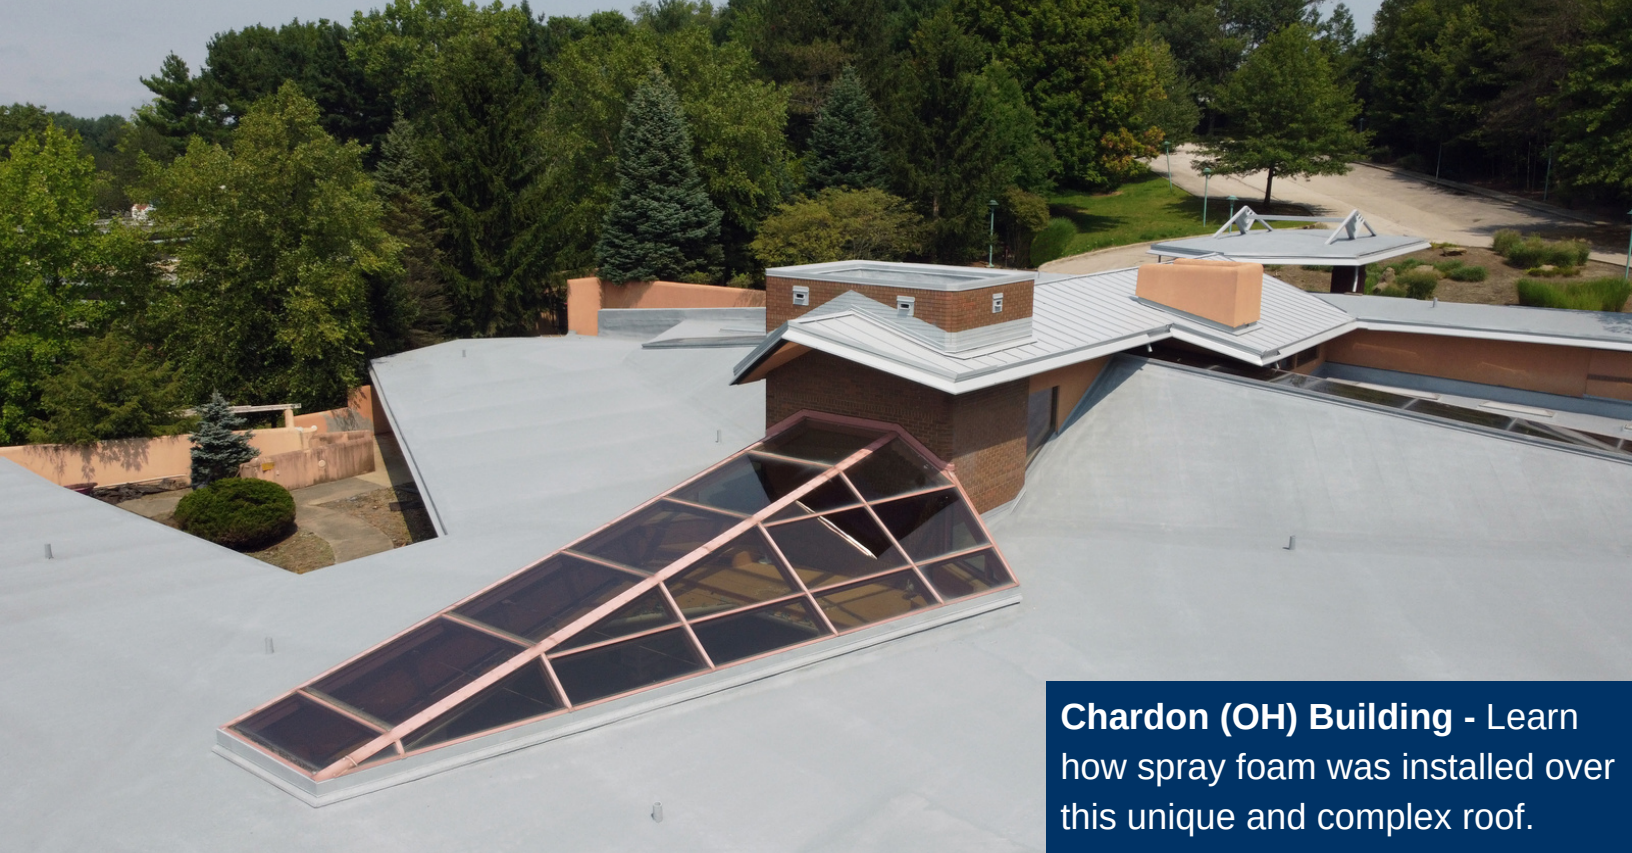
The building's roof is unique in appearance as it looks like the shape of two airplanes.

There simply is no flat area on this roof. Every foot is sloped up or down. With spray foam being fluid-applied and seamless, the installation was much easier and more cost-effective than a traditional roofing system would be.

The loose gravel was hydro-vacuumed off the roof.

All skylights and exposed roof areas were covered with plywood for safety.

The roof received an average of 1.5" of closed-cell polyurethane foam.

20 mils of Urethane coating was installed.
