Project Name: St. Vladimir - Dome

Recoat

Project Overview: Acrylic base/top coat over existing coating

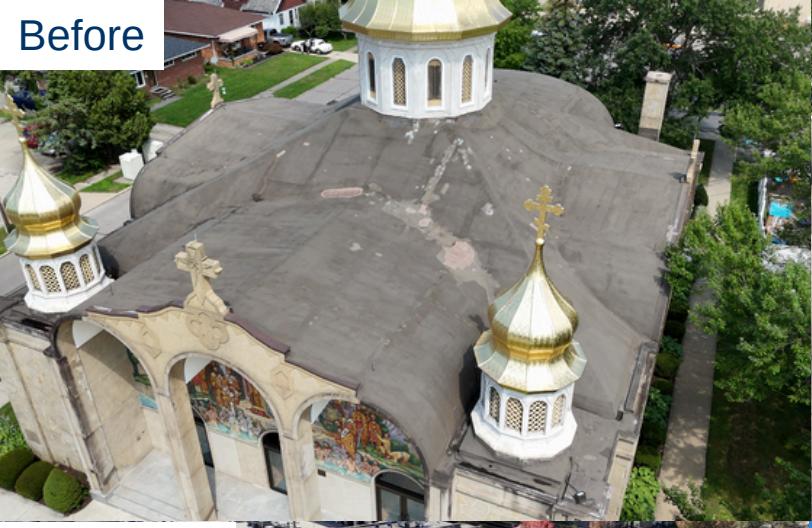
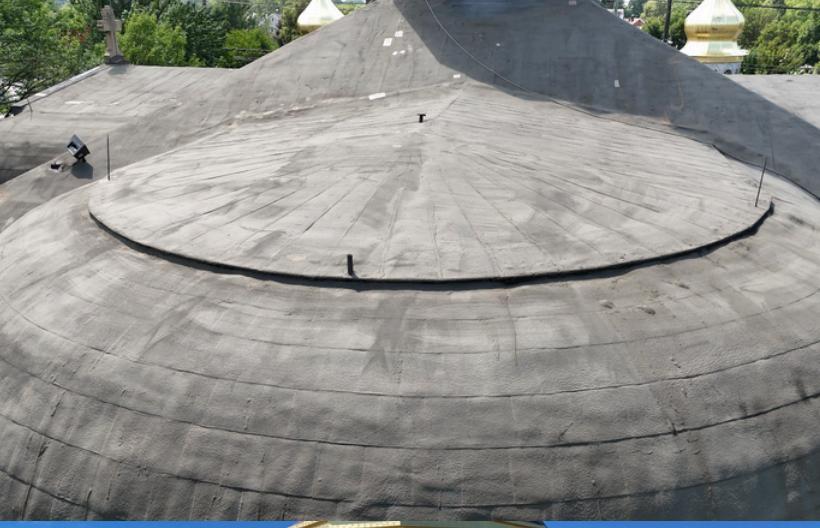
Before

The roof has an internal gutter system that was holding water.

We increased the slope of the gutter system and applied a high-solids silicone coating to withstand the large volume of water draining from this roof.
